**NASA TM X-73514**

**STATUS OF 30-CENTIMETER-DIAMETER MERCURY  
ION THRUSTER ISOLATOR DEVELOPMENT**

by M. A. Mantenieks  
Lewis Research Center  
Cleveland, Ohio 44135

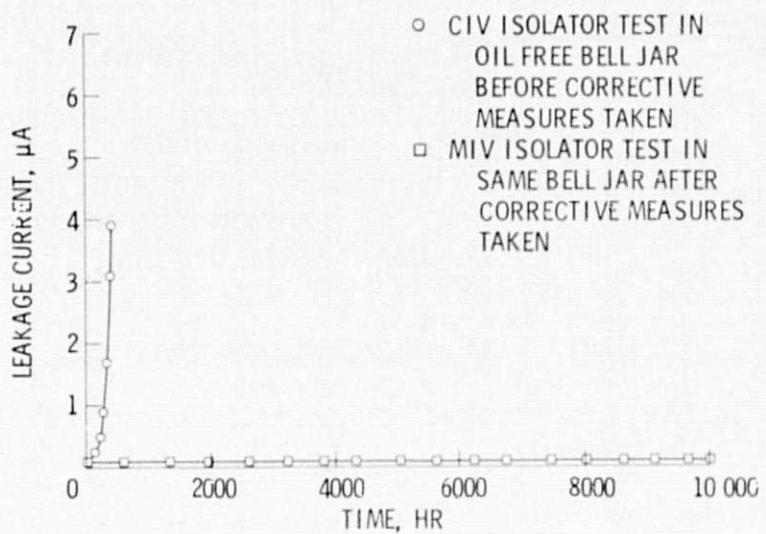
Figure 3. - Leakage current with time of MIV test.

The initial current of the isolator was 0.1  $\mu$ A at 1500 volts, which corresponds to approximately the bulk conductivity of the alumina in the isolator. There was no increase of this current in the 10,000 hours of operation (fig. 3) at which time this test was terminated. During this time period the isolator test underwent 17 shutdowns during which pressure increases of up to about  $1 \times 10^{-4}$  torr range occurred. These shutdowns had no apparent detrimental effects on the isolator performance. After the test the isolator was inspected and, as expected, was found to be in excellent condition.

Therefore, it may be concluded that the external leakage current source has been identified as self contamination, probably due to the evaporation-condensation mechanism discussed before, and that the implemented design changes have corrected the failure mode leakage current problem.

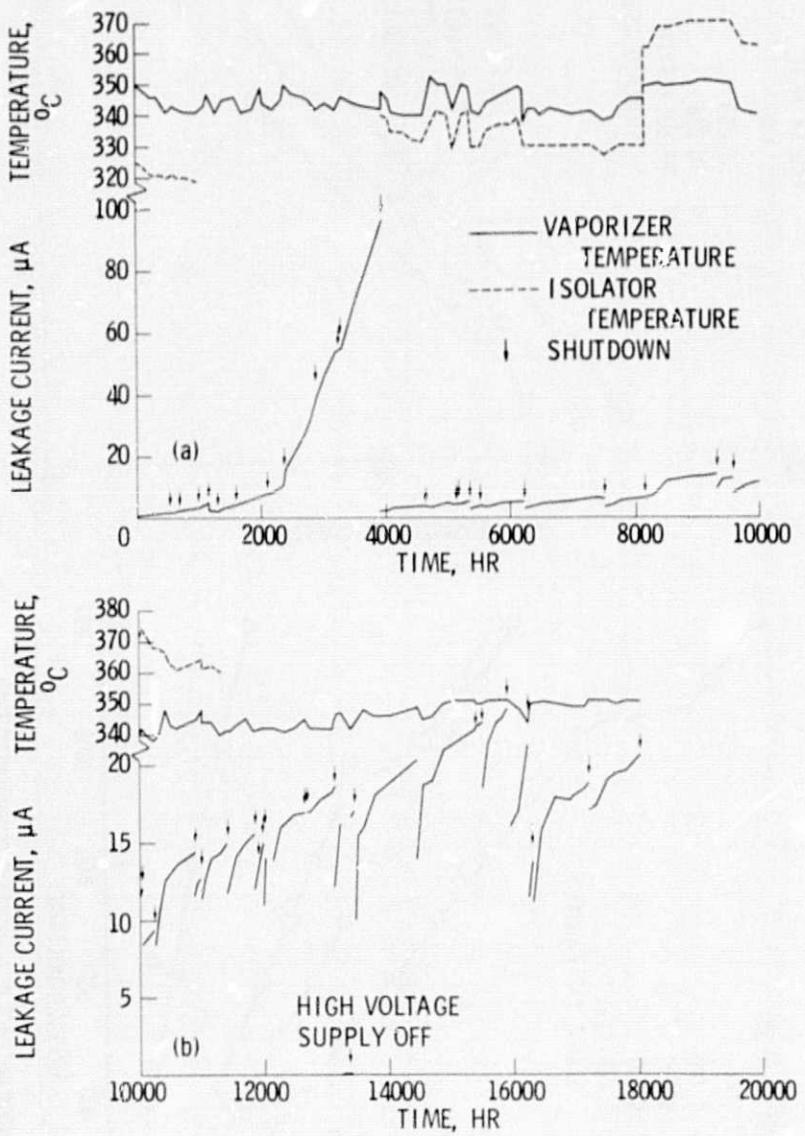
Figure 4. - Leakage current with time of CIV endurance test.

The cathode performance including discharge and keeper conditions and tip temperature appear in reference 19. The leakage current history of the 10,000 test and the corresponding isolator and vaporizer temperatures during the test are shown in figure 4. The initial isolator leakage current of 1.  $\mu$ A indicated that some surface contamination could have been present before the lifetest. However, as shown later the indicated leakage current may also have been due to contaminated high voltage feedthroughs, leakage across power supply isolation insulators, or discharge plasma leakage. However, it was concluded in reference 8 that higher than normal initial leakage currents due to some isolator contamination did not necessarily contribute to early onset of exponential increases of the isolator leakage current, so this initial leakage current was not a matter of major concern.

From figure 4 it can be seen that the leakage current slowly increased for approximately the first 1100 hours at an average rate of about  $2.2 \times 10^{-3}$   $\mu$ A/hour. A sudden drop of leakage current at about 1130 hours was due to cleaning of all insulators on the port flange feedthroughs and the floating power supplies. At about the same time the isolator

thermocouple malfunctioned. From about 1130 to 2400 hours on the test the average leakage current increase with time was about  $6.7 \times 10^{-3}$   $\mu\text{A}/\text{hour}$ . The vaporizer thermocouple reading indicated that the increase may have been associated with a slightly higher isolator-vaporizer temperature.

At 2400 hours, the discharge power supply malfunctioned and probably overheated the cathode and isolator and a shutdown took place. After repairs to the power supply, a restarting of the cathode discharge, the keeper voltage and cathode tip temperature exhibited abnormal conditions for some time, which indicated that during this shutdown, also the cathode was adversely affected. From this startup at 2400 hours until the 3950-hour mark the leakage current increased with time at a faster rate of about  $5.6 \times 10^{-3}$   $\mu\text{A}/\text{hour}$  with no increase indicated on the isolator temperature during that time period. This sudden increase of leakage current rate is attributed to the abnormal shutdown caused by the faulty power supply.

From 3950 to 8150 hours the leakage current increase with time averaged only about  $1.2 \times 10^{-3}$   $\mu\text{A}/\text{hour}$  at an average isolator temperature of about  $330^\circ\text{C}$ . A unique phenomenon, not observed on previous isolator tests, was first observed on the isolator leakage current after the shutdown at the 5010-hour point. The leakage current on restarting was found to have decreased considerably from the value measured before the shutdown. Later it was determined that these leakage current decreases were only associated with shutdowns in which the CIV was exposed to atmospheric conditions. Therefore, this phenomenon is assumed to be associated with the oxidation of the thin film responsible for the leakage current. However, this phenomenon is not well understood at this time. The leakage current reduction after a shutdown involving atmospheric exposure appeared to depend on the temperature required during preheat to restart the cathode. It was observed that the magnitude of the decrease in leakage current after a shutdown increased with increasing isolator temperature reached during startup. After such a decrease the leakage current increased with time at an accelerated rate for a while until the previous normal rate was attained.

At the 8150-hour mark, the plasma sprayed cathode tip heater burned out. Because heaters as originally fabricated cannot be replaced on cathodes, a makeshift heater was installed by wrapping several windings of heater material around the cathode tip in order that the isolator test might be continued. Additional heat shielding around the cathode tip was added to assist cathode startup. This change resulted in a higher operating temperature ( $\sim 350^\circ\text{C}$ ) of the isolator. This, in turn, resulted in a somewhat higher average leakage current increase with time of about  $3.9 \times 10^{-3}$   $\mu\text{A}/\text{hour}$ .

determine if any deterioration had occurred on the inside of the isolator. After the bead blasting the isolator it was also necessary to replace the heater and heat shielding. The leakage current after this operation did not return to the 2  $\mu\text{A}$  value which was measured after the previous bead blasting operation at 3950 hours but rather decreased only to 12.5  $\mu\text{A}$ . This result, however, was somewhat obscured by the fact that the cathode did not operate normally for some time after the restart, resulting in abnormally high isolator temperatures compared with the operation before the shutdown at 8150 hours. Two explanations are possible for the observed remaining leakage current after the bead cleaning operation at 16,258 hours: either the cleaning operation was not entirely successful in removing all of the outside isolator contamination or the observed leakage current after the shutdown was an internal isolator phenomenon.

After 3950 hours in the test, the isolator was removed, the surface was bead blasted, and a new shadow shield made from tantalum was installed. The leakage current after the bead blasting was reduced to about 2  $\mu\text{A}$  at  $350^\circ\text{C}$ , which was slightly higher than at the beginning of the test. This leakage could have indicated a slight degradation of the internal structure of the isolator.

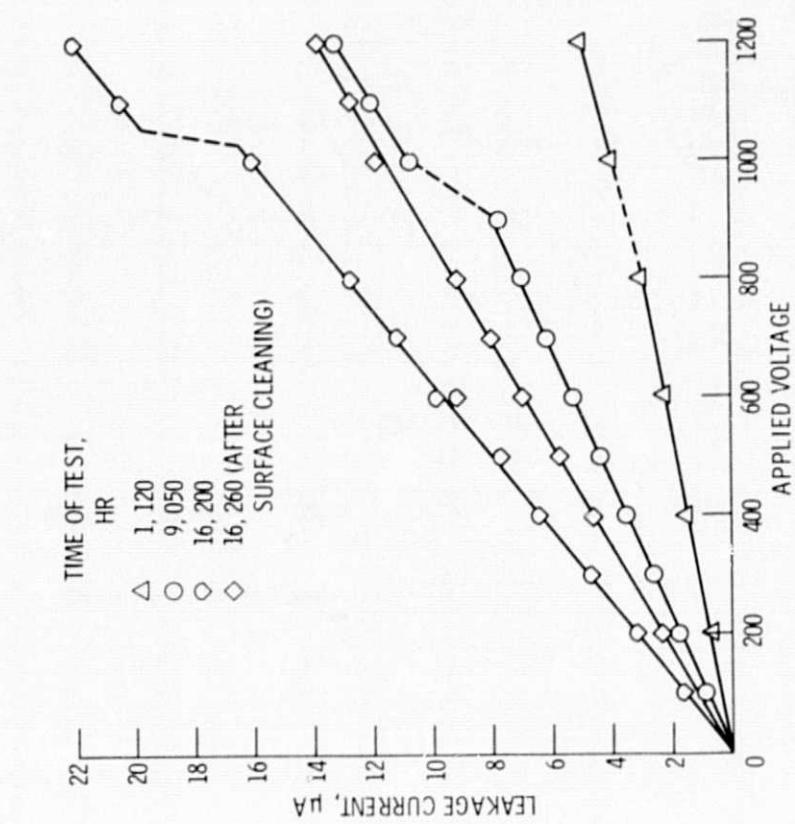
Figure 5. - Leakage current as a function of applied voltage.

It is of interest to compare the plots of the voltage vs. leakage current and of the leakage current vs. the reciprocal of the isolator temperature for times before and after the cleaning operation at 16,258 hours. Figure 5 shows that after the cleaning operation the previously observed sudden transition in the V-I plot occurring at around 1000 volts disappeared. The reason for the transition is not understood. Current-voltage plots found in reference 8 exhibited ohmic behavior with some exceptions at very high voltages, and the deviation observed from ohmic behavior was gradual, not like the transition observed in figure 5. A gradual deviation is consistent with thin film behavior found in literature.

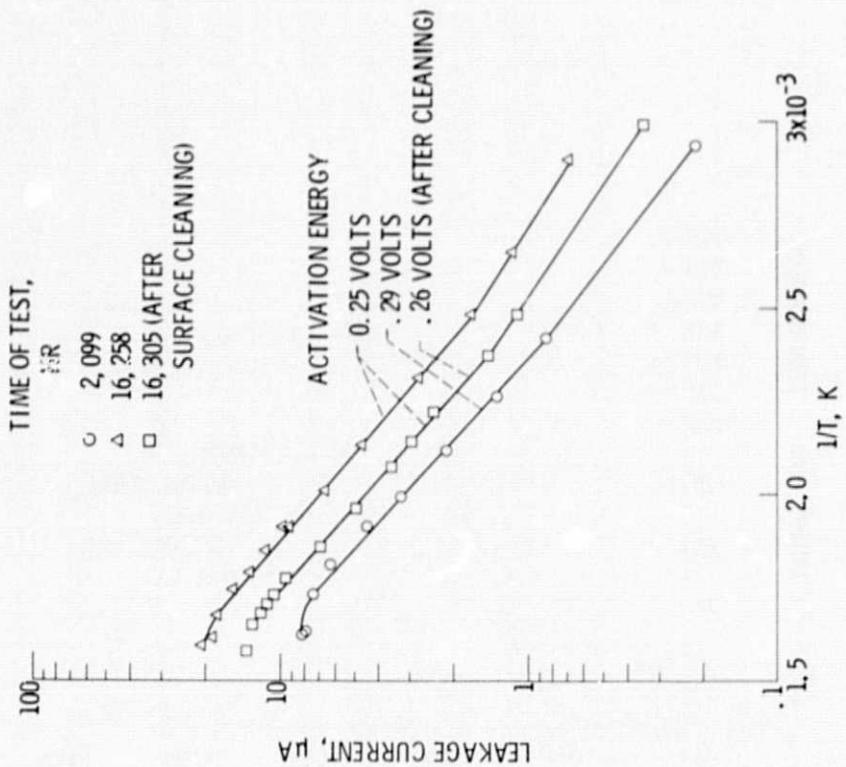
Figure 6. - Leakage current as a function of reciprocal isolator temperature.

Figure 6 shows the leakage current as a function of the reciprocal of the isolator temperature plot at various times of the test. The data taken after the isolator cleaning showed the same characteristics as observed before the cleaning. The characteristic activation energy of a semiconductor was found to decrease with time between 2099 and 16,258 hours as was observed in similar plots in reference 8. Again these observed characteristics are found to be consistent with thin film semiconductor behavior.
